Operational Evaluation Test of Mine Clearing Cultivator and Mine Clearing Sifter

January 2005

**Institute for Defense Analyses
4850 Mark Center Drive
Alexandria, VA 22311-1882**

**Humanitarian Demining Research
and Development Program**
Night Vision and Electronic Sensors Directorate
10221 Burbeck Road, Suite 430
Fort Belvoir, VA 22060

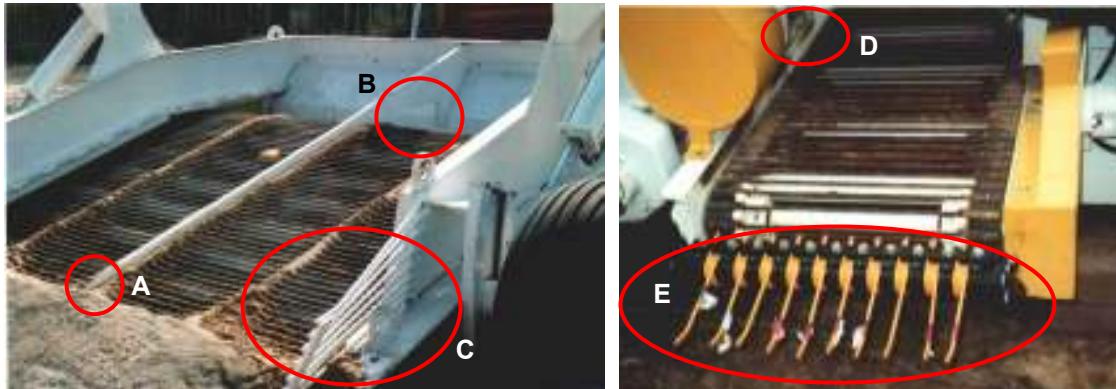
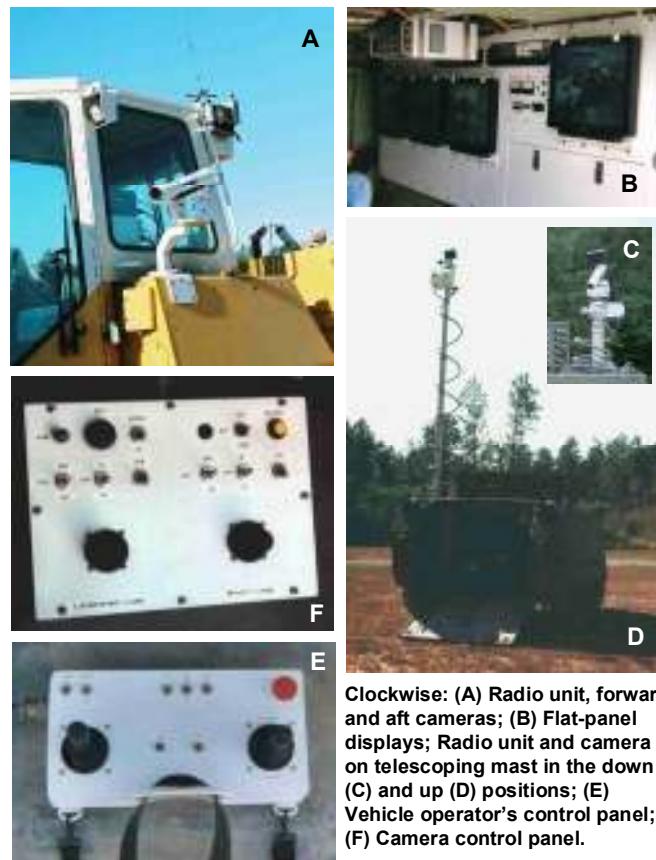
Figure 9: Modifications Made to the MCS

After testing the MCS in 2002, a number of improvements (see Figure 9) were made based on observations during the test. The front of the fore-aft center support beam

(A) was tapered to fare into the nose scoop due to a couple of mines becoming stuck against the blunt end of the support beam. The cutout (B) in the center beam over the rear conveyor belt was raised to allow AT mines to pass under the center beam on the discharge belt. Side bars (C) were added at the front of the sifter to prevent mines from going over the side with excess dirt spillage before reaching the sifting conveyor belt. To prevent small AP mines from falling to the ground beneath the sifter, a rubber guard (D) was added below the primary conveyor belt to close a gap between the primary sifting belts and the discharge conveyor belt. Finally, a short, wire chute (E) was added to the end of the discharge chute to insure that mines leaving the sifter were deposited outboard of the prime mover's tracks.

(A) Support Beam Faring , (B) Increased Clearance, (C) Side Bars, (D) Rubber Guard, (E) Discharge Chute
